CURRENT ENGINEERING PRACTICE OF PAVEMENTS MAINTENANCE IN CHINA

***Abstract:** This paper focused on current construction practice for pavement maintenance of expressway in China. It included identification of typical pavement section distresses, evaluation of pavement condition through surface distress rating, ride quality index(RQI), international roughness index (IRI), pavement condition index(PCI), mechanical performance test and pavement performance tracking. Different treatments are applied based on the distress level. Mix design of some new materials is given. New technologies: Thiopave asphalt, Buton rock asphalt (BRA), hot-in place recycling, foam asphalt cold recycling and rubblization method have been explained and put into engineering practice through some case studies. The application of the different technologies on practical engineering project has given satisfactory results.*

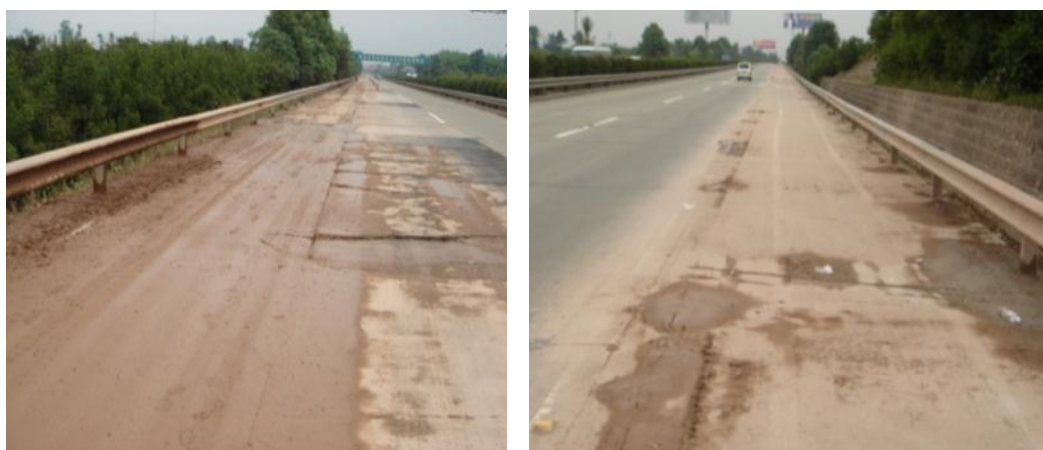
Fig 1. Original pavement condition

After crushing the original pavement with hammer, a certain thickness has been implemented as overlay and the pavement structure is shown below:

- 20 cm cement stabilized crushed stone subbase
- 20cm cement stabilized macadam base
- 6cm medium grained conventional asphalt concrete AC-20
- 6cm medium grained modified asphalt concrete AC-20
- 4cm modified stone mastic asphalt SMA-13.

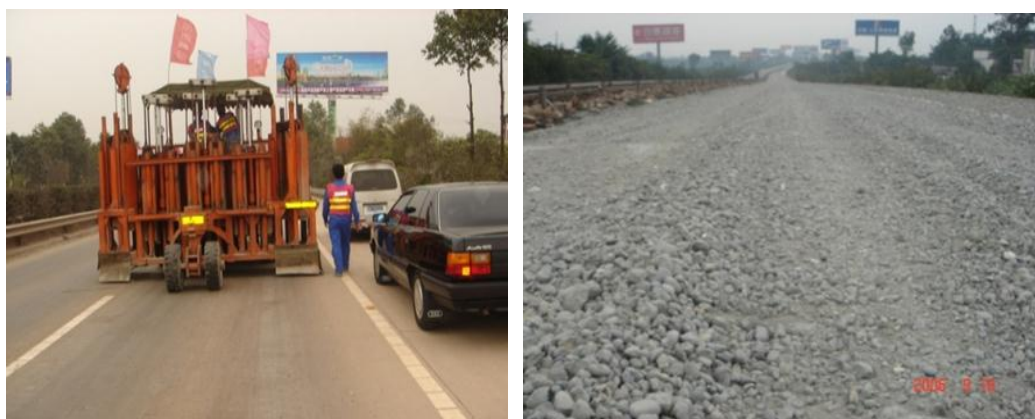
Fig 2. Construction process

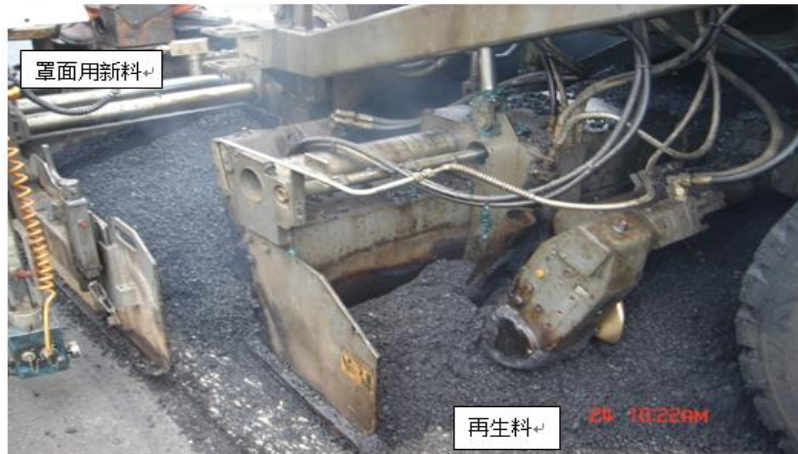
Fig 4. Tracking observation after hot-in place regeneration

After application of hot-in place recycling overlay in Chongqing Chengdu expressway; deflection, pavement distresses, rutting and pavement roughness were evaluated to see the effect of its application as overlay. Tables 23 to 26 respectively give details of each pavement component measured. From table 23 it can be noticed that in 2005 and 2007, deflection data has been detected in both lanes. In 2006, 2008, and 2010: only the main lane has been put into account for deflection detection. From 2005 to 2010 the deflection of the pavement decreases considerably. In 2009, Comprehensive test vehicles have been used to detect the road surface damage condition. According to the results obtained of the original road in table 24, there are no obvious types of distresses. The track of the test section was detected by laser beam profiler in 2008 and 2009, and the results of the detection of the hot in place recycling rutting test are in table 25. From table 25, it can be concluded that by 2009 most of pavement sections are either in good or fair condition. Only two pavement sections are in poor condition. Table 26 showed that pavement smoothness is also in good condition.

Hot in place recycling technology is used as overlay in Chengdu - Chongqing Expressway K42-K47 section as pavement test section. On the top of the original pavement surface, 3 to 5cm of hot - in place regeneration is applied followed by 4cm of conventional asphalt mixture. A total of 170 Km of road test has been implemented based on experience and a tracking observation has been investigated as shown in figure 4.
