CURRENT ENGINEERING PRACTICE OF PAVEMENTS MAINTENANCE IN CHINA

***Abstract:** This paper focused on current construction practice for pavement maintenance of expressway in China. It included identification of typical pavement section distresses, evaluation of pavement condition through surface distress rating, ride quality index(RQI), international roughness index (IRI), pavement condition index(PCI), mechanical performance test and pavement performance tracking. Different treatments are applied based on the distress level. Mix design of some new materials is given. New technologies: Thiopave asphalt, Buton rock asphalt (BRA), hot-in place recycling, foam asphalt cold recycling and rubblization method have been explained and put into engineering practice through some case studies. The application of the different technologies on practical engineering project has given satisfactory results.*

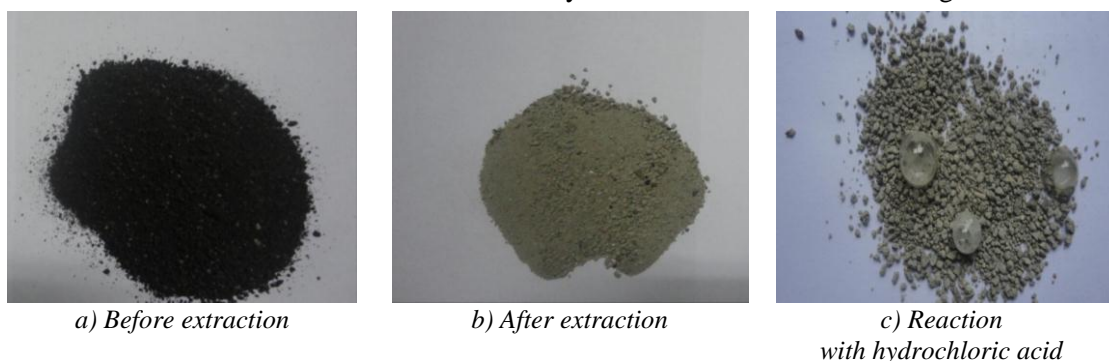
Buton rock modified asphalt overlay was constructed on November 2008. It was overlaid over an original modified asphalt mix AC-13 for a given section. Indonesian buton rock asphalt (BRA) is a production from the Indonesian buton Island submarine rock asphalt. It is broken by mining into fine powder particles which have a light brown color. Trichloroethylene as solvent and automatic extraction Infratest 20-1120 instrument detection were used to extract asphalt content from the rock and final mineral aggregates has resulted. Table 18 shows the BRA extraction test results (in Appendix) and its screening results before and after extraction is shown in table 19. In table 18 it is shown that BRA asphalt content is 21.7% and the mineral aggregate percentage accounts for 78.9. Before extraction buton rock asphalt screening are too coarser with maximum particle size of mineral aggregate control below 1.18mm. More than 70% of mineral particles diameter are less than 0.15 mm after extraction. Fine, mineral particles mainly composed of limestone (reacted with hydrochloric acid to bubble), have strong adsorption of asphalt and used as powder. Fine mineral particles of buton rock asphalt mix before and after extraction and its reaction with hydrochloric acid are shown in figure 3.

Fig 3. Fine mineral particles of buton rock asphalt mix:
a) before extraction; b) after extraction; c) reaction with hydrochloric
